FIBERCILL

The Moorings, Brierley Hill DY5 1UX

INFORMATION

BACKGROUND

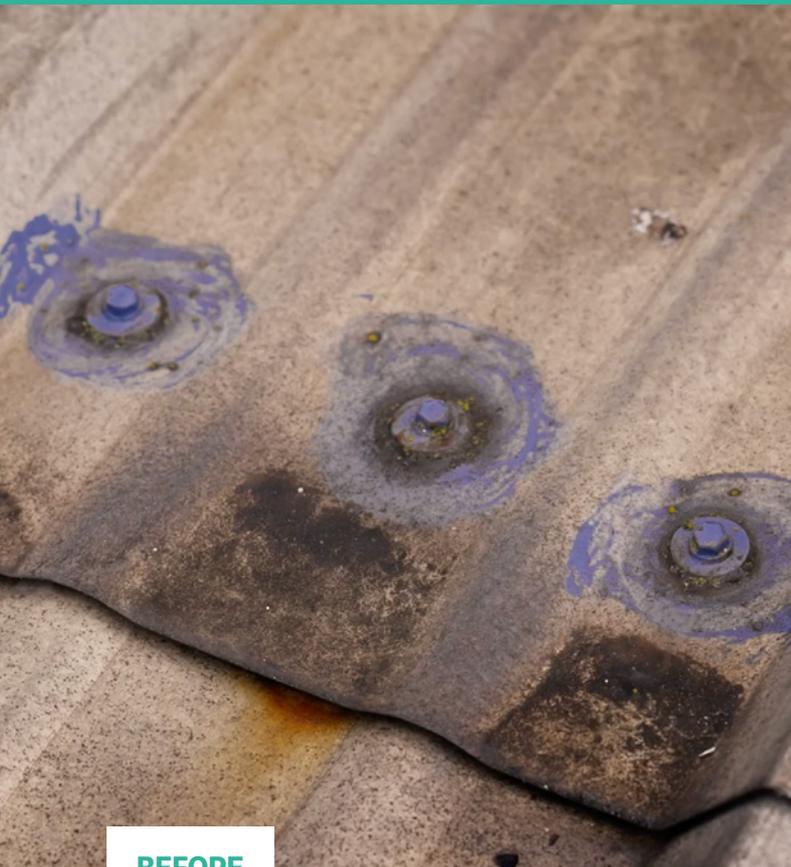
BEFORE

A UK-based manufacturer, specialising in MDF primed moulding for the building industry, Fibercill's facility in Dudley was experiencing issues with its zinc-sheet roof. A history of cut-edge corrosion had led to repairs over the years, which were now starting to fail - requiring a long-lasting, protective solution.

Though old, the existing zinc roof sheets were found to be in a reasonable condition. However, over the years various repairs had been made to the sheet edges and fixing and these repairs were now failing. There was also some evidence of corrosion to sheets located closed to the extraction vents.

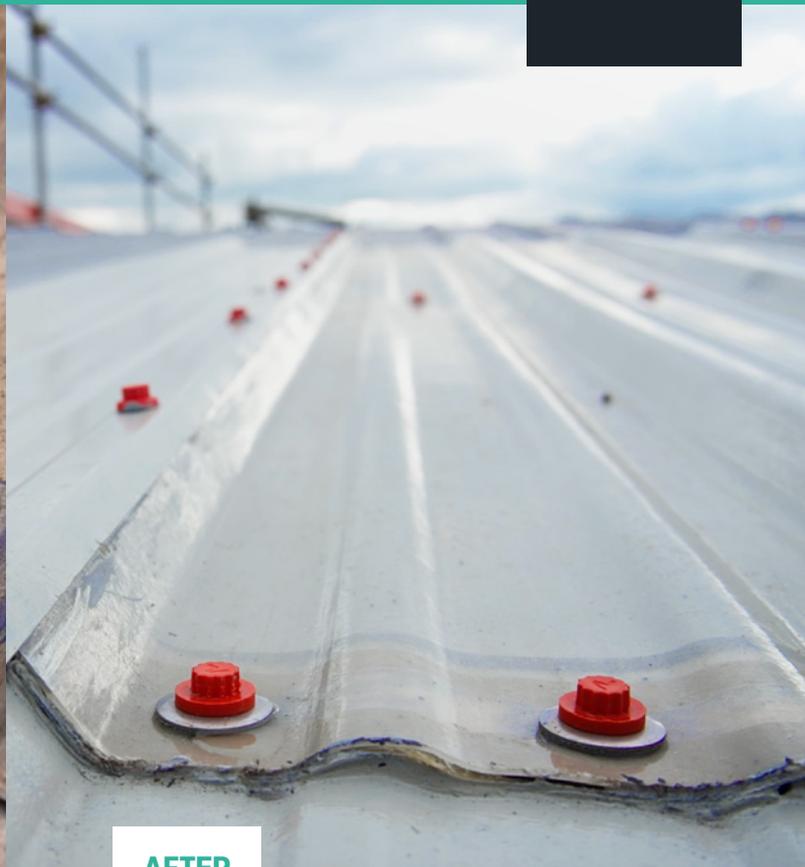
AFTER

All zinc roof sheets were then primed with Raincoat APA, an anti-corrosive designed to promote adhesion. Uncover S Top Coat was then applied over the full roof surface to complete the system.
