# Hard Rock Cafe, Edinburgh

18 George Street, Edinburgh

Tor Coating system used:

**Elastaseal Z**

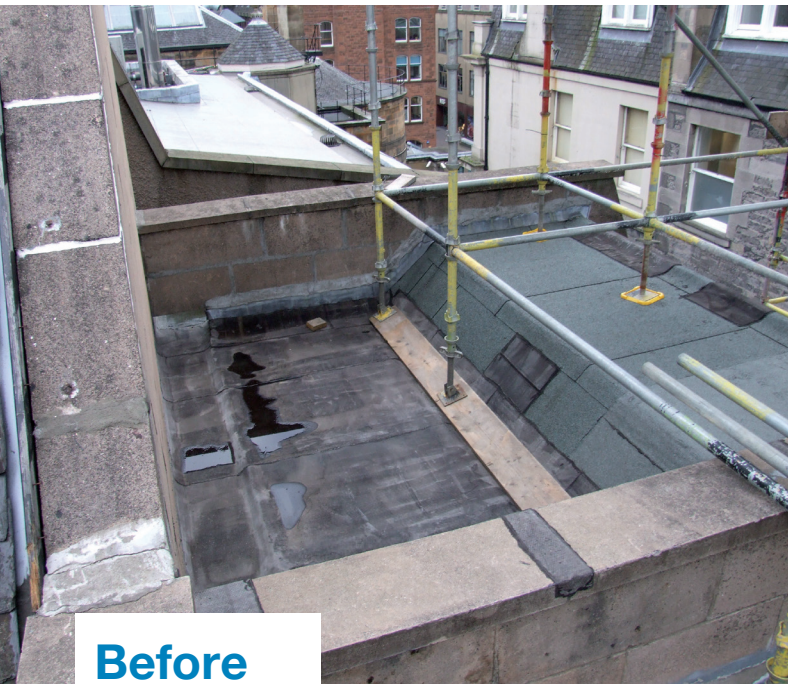
Before the correct coating system could be specified, Tor Coatings carried out a comprehensive free survey of the site to ensure every aspect of the project was clearly understood and all defects were documented thoroughly. The Georgian building had flat roofs to the rear which the survey found were beset with problems. The survey found that the GRP and felt membranes - designed to waterproof the roofs - had failed in a number of places over a period of years. Countless attempts to repair the roof ultimately proved ineffective and repeated water ingress became a major concern for the landlord and tenants.

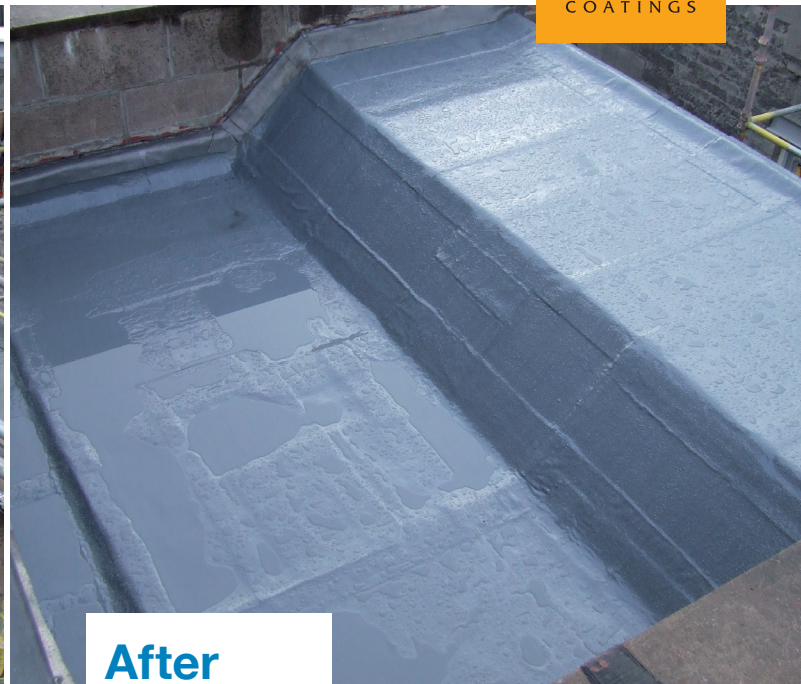
After

The project was carried out by Roofing Consultants Ltd with site support from the Tor sales and technical service team. The Elastaseal Z coating system is compatible with almost all sound roofing materials so there was no need to strip out the existing roofing membranes and the coating was completed while the building remained fully operational.

The client found the perfect long term solution to the problem in the form of Elastaseal Z from Tor Coatings. The liquid roof coating system could be applied to all areas of the roof and used to encapsulate critical areas of roof mounted plant and protrusions; providing an overall waterproof membrane that could not be achieved by any other method. Elastaseal Z works by providing the roof with a seamless barrier membrane, that is not only 100% waterproof but also allows the roof to breathe.

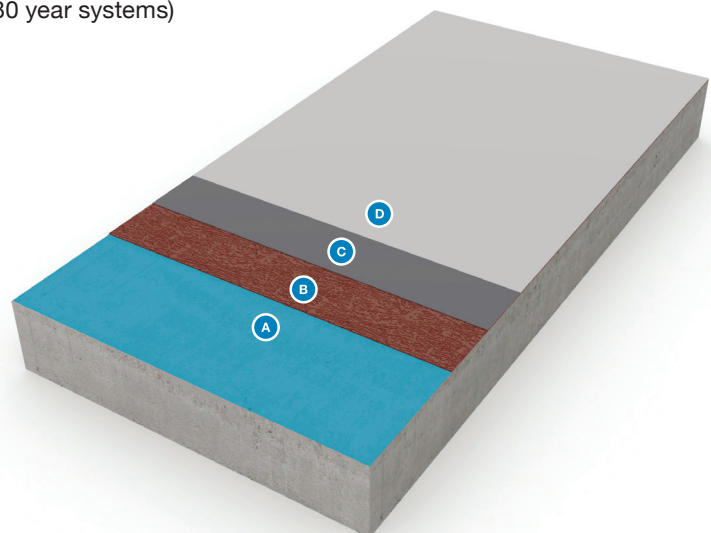
### Typical build-up of the Elastaseal Z system

- A** Prepared existing roof substrate
- B** Elastaseal embedment coat with Elastamat™ glass fibre reinforcement
- C** Elastaseal top coat
- D** Additional Elastaseal top coat (for 30 year systems)
