# Hard Rock Cafe, Edinburgh

18 George Street, Edinburgh

## Background

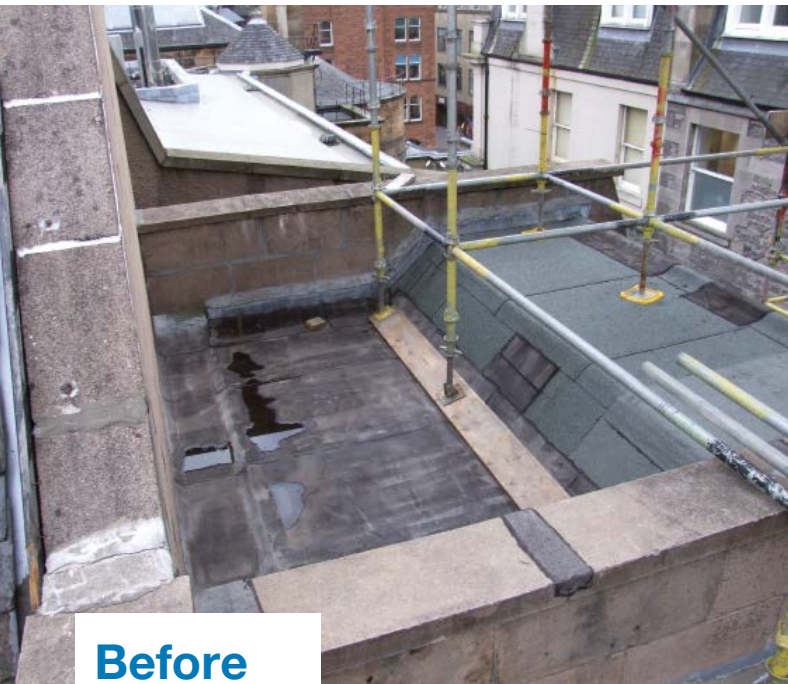
Before the correct coating system could be specified, Tor Coatings carried out a comprehensive free survey of the site to ensure every aspect of the project was clearly understood and all defects were documented thoroughly. The Georgian building had flat roofs to the rear which the survey found were beset with problems. The survey found that the GRP and felt membranes - designed to waterproof the roofs - had failed in a number of places over a period of years. Countless attempts to repair the roof ultimately proved ineffective and repeated water ingress became a major concern for the landlord and tenants.

The client found the perfect long term solution to the problem in the form of Elastaseal Z from Tor Coatings. The liquid roof coating system could be applied to all areas of the roof and used to encapsulate critical areas of roof mounted plant and protrusions; providing an overall waterproof membrane that could not be achieved by any other method. Elastaseal Z works by providing the roof with a seamless barrier membrane, that is not only 100% waterproof but also allows the roof to breathe.

The project was carried out by Roofing Consultants Ltd with site support from the Tor sales and technical service team. The Elastaseal Z coating system is compatible with almost all sound roofing materials so there was no need to strip out the existing roofing membranes and the coating was completed while the building remained fully operational.

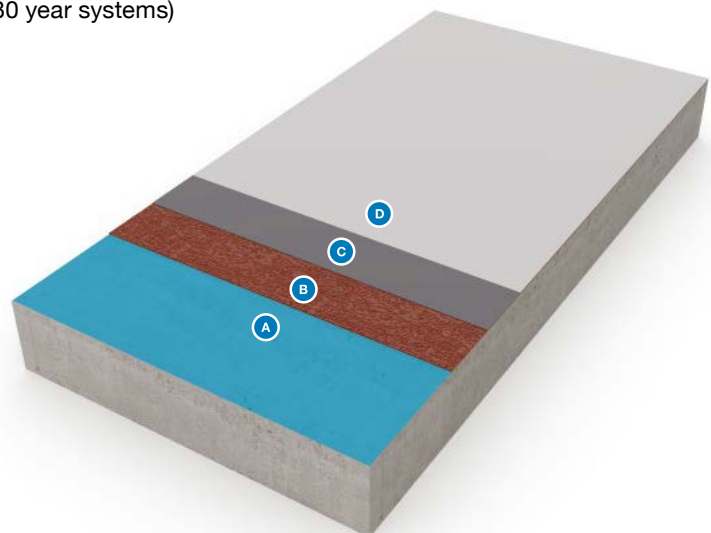
### Typical build-up of the Elastaseal Z system

- A** Prepared existing roof substrate
- B** Elastaseal embedment coat with Elastamat™ glass fibre reinforcement
- C** Elastaseal top coat
- D** Additional Elastaseal top coat (for 30 year systems)
