# Cranham Industrial Estate

Units 15 & 16 Cranham Industrial Estate Worcester

Category Roofing

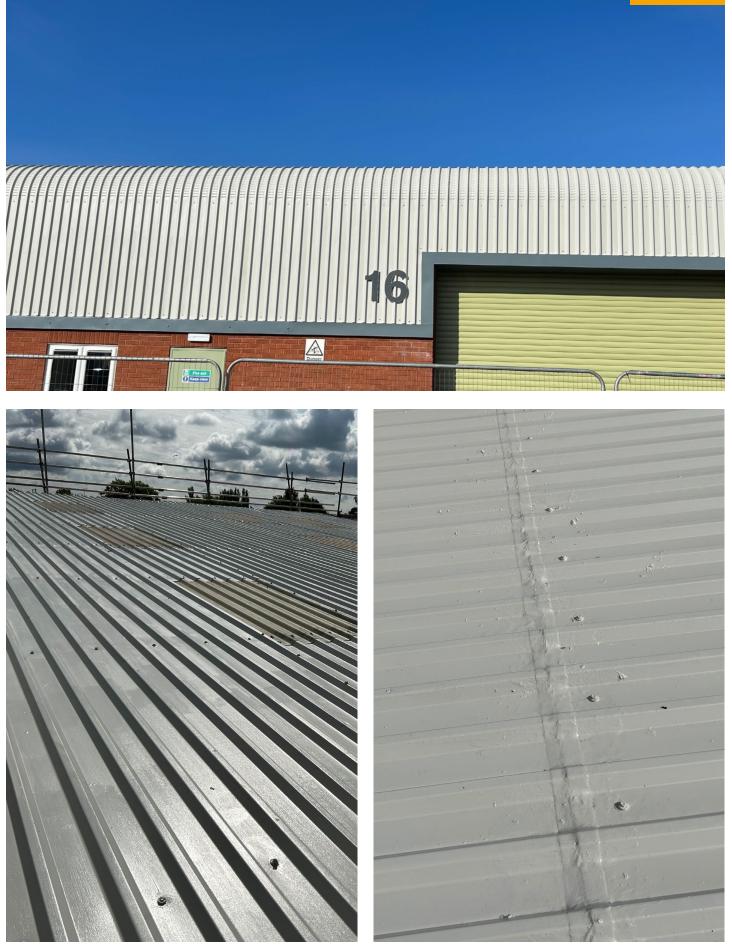
The roof and cladding coating works were being undertaken as part of new tenancy packages. The existing coatings to the roof were aged and very dirty, and the cut edges of the sheets were showing signs of surface corrosion. The cladding coatings were in reasonable condition but the existing coating was nearing the end of its useful life. The client was looking for a long-term, cost effective solution that would provide a 15 year warranty for the roof and the cladding.

The Unicover Ultra S system, including EdgeProtect cut edge corrosion system, was specified to ensure that the roof and cladding sheets were protected and the cut edge corrosion was halted with a durable, high performance 15 year system.

The works were undertaken by TMS Contractors, who jet washed the roofs and cladding, mechanically abraded all of the cut edge corrosion to remove failed coatings and surface corrosion and then primed all of the bare areas. The roof and cladding sheets were then coated with two coats of Unicover Ultra S, a high-performance, moisture-triggered coating system.
