Tor Coating system used:

Background

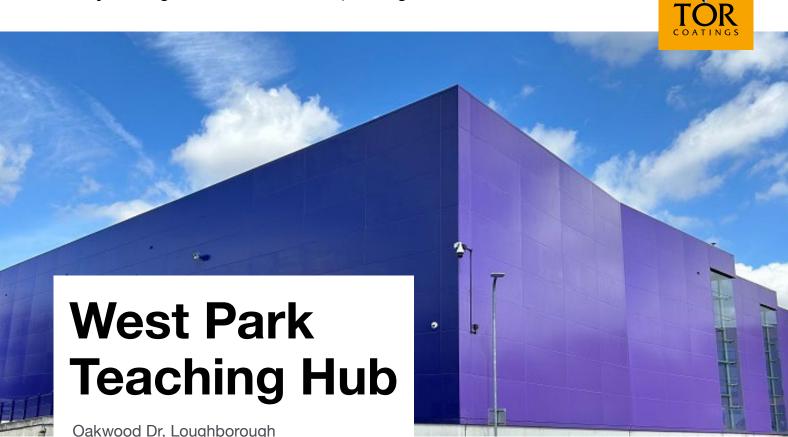
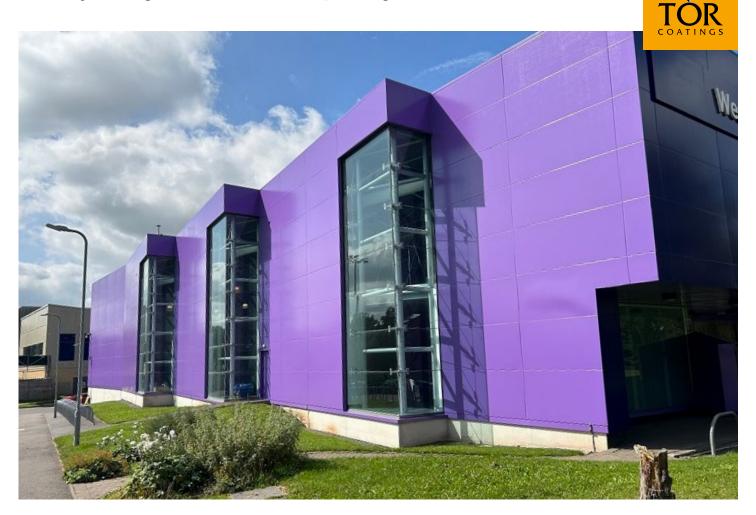
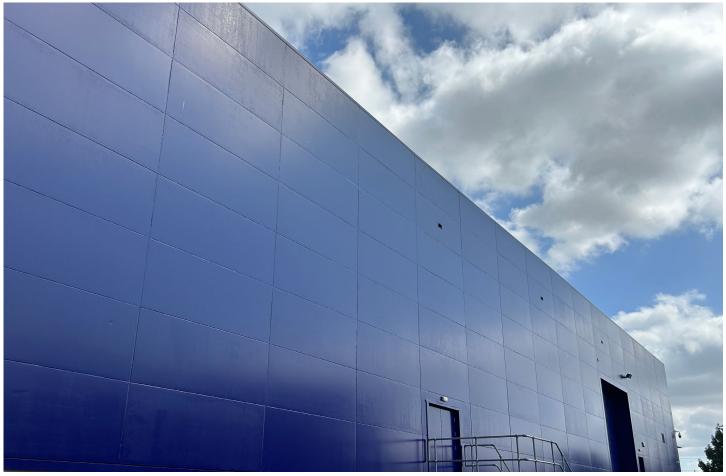
The existing coating had reached the end of its life and was breaking down in areas, particularly on the rear and side elevation. The client was also looking to incorporate their corporate colours into the building.

The project was carried out by Cladding Coatings, who jet washed and mechanically abraded the surfaces to ensure that they were clean and that all failed coatings were removed back to a sound edge. The bare metal areas were then primed with Raincoat APA primer prior to the application of two coats of Unicover S. Access to the cladding was achieved on most of the elevations with the use of MEWPs/Scissor Lifts, but one section of the side elevation was scaffolded due to the ground being unsuitable for the mechanical lifts.
