The Paragon Estate

Boston Manor Road, Brentford, London, TW8 9QW

Tor Coating system used:

**Elastaseal Z™**

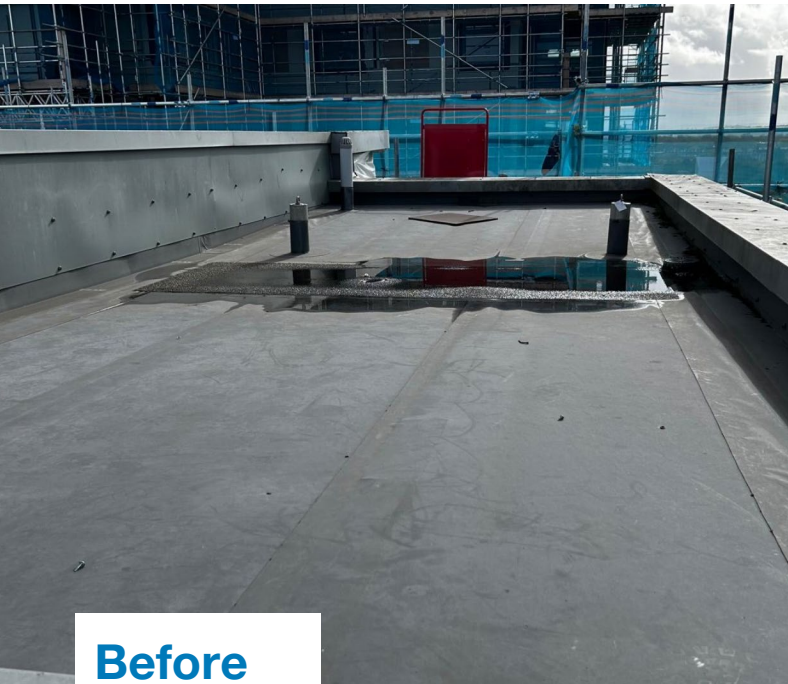
Before

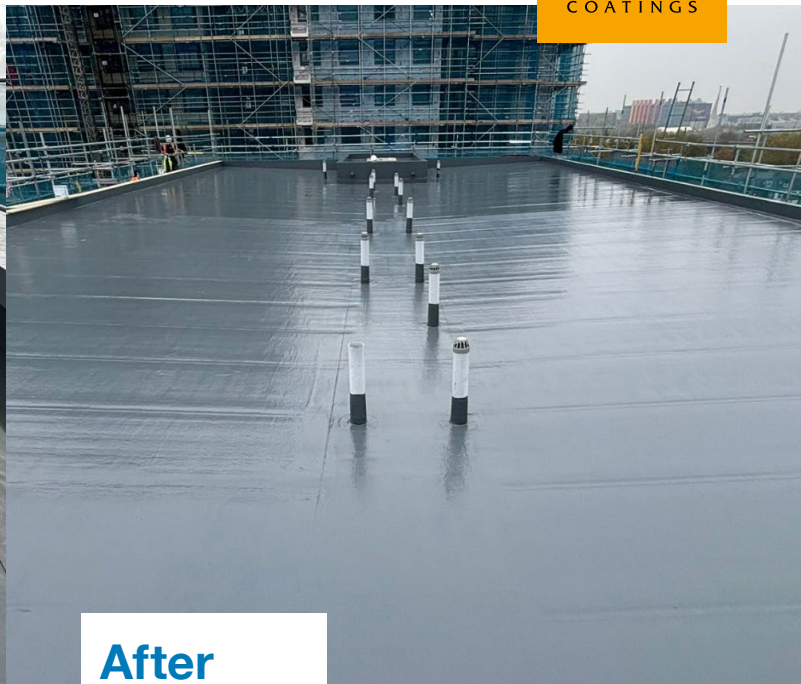
After

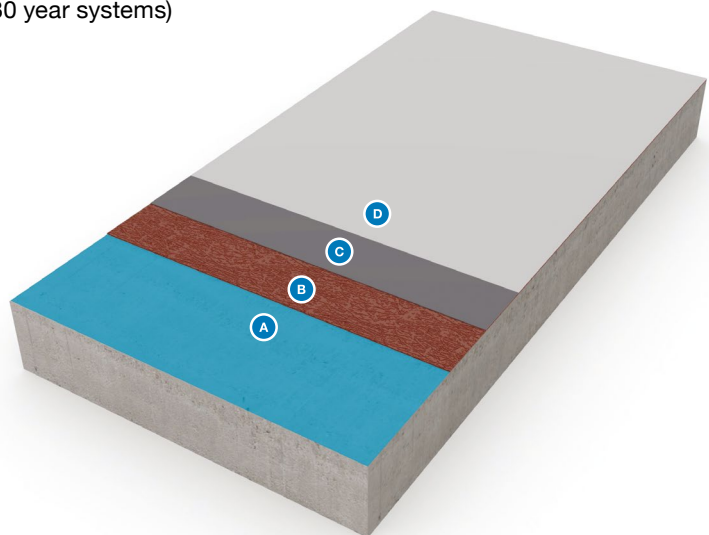
Typical build-up of the Elastaseal Z system

- A** Prepared existing roof substrate
- B** Elastaseal Z embedment coat with Elastamat™ glass fibre reinforcement
- C** Elastaseal Z top coat
- D** Additional Elastaseal Z top coat (for 30 year systems)
