ASTRA ZENECA GAWSWORTH BUILDING

Gawsworth Building, Alderley House, Astrazeneca, Macclesfield, Stockport, SK10 2NA

TOR coating system used:

ELASTASEAL Z

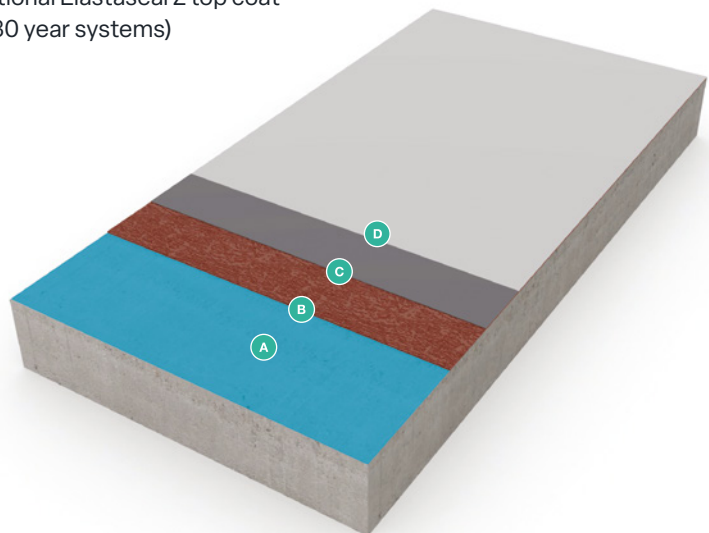
TYPICAL BUILD-UP OF THE ELASTASEAL Z SYSTEM

- A** Prepared existing roof substrate
- B** Elastaseal Z embedment coat with Elastamat™ glass fibre reinforcement
- C** Elastaseal Z top coat
- D** Additional Elastaseal Z top coat (for 30 year systems)
