# STOCKPORT HOMES

Stockport, Greater Manchester

### TORREX 3

### Fire Protection

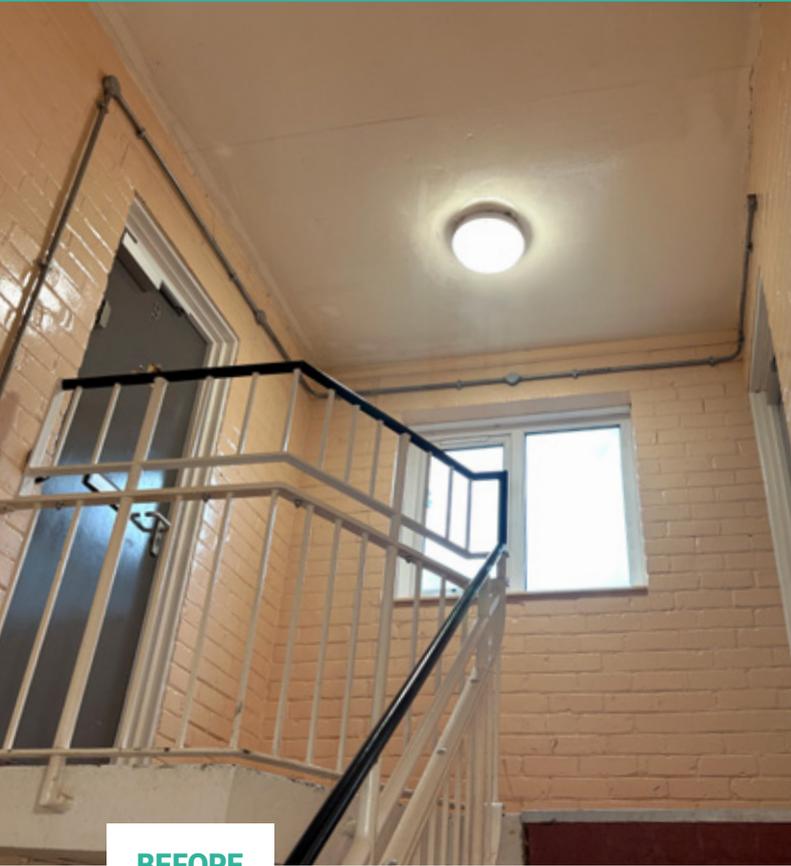
BEFORE

One of their sites required refurbishment to internal walls as the original coated face brick did not meet Euroclass B requirements. A compatible and robust coating system was needed, with comprehensive and carefully considered work to properly prepare the original brick face substrate prior to application.

A comprehensive survey of the site was carried out. During the inspection it was identified that the previous coating was an anti-graffiti coating. This required mechanical abrasion to flatten the surface before overcoating with the proposed Torrex 3 fire upgrade system.

Testing carried out on site confirmed that the existing coating on the brickwork was suitable for overcoating as it demonstrated adequate adhesion through a series of adhesion checks.

Approved contractor for the Torrex 3 system, B4. Box washed down all areas using Tor WDA 10 before mechanically abrading the entire surface to remove high points in the previous coating and create a sound, uniform substrate. Following this, manual intervention was also needed, as individual cracks had to be addressed by hand.

During the application of the Torrex 3 coating, a medium-pile roller was transitioned to a long-pile roller in order to achieve the required wet-film thickness and a uniform finish across the uneven surface.

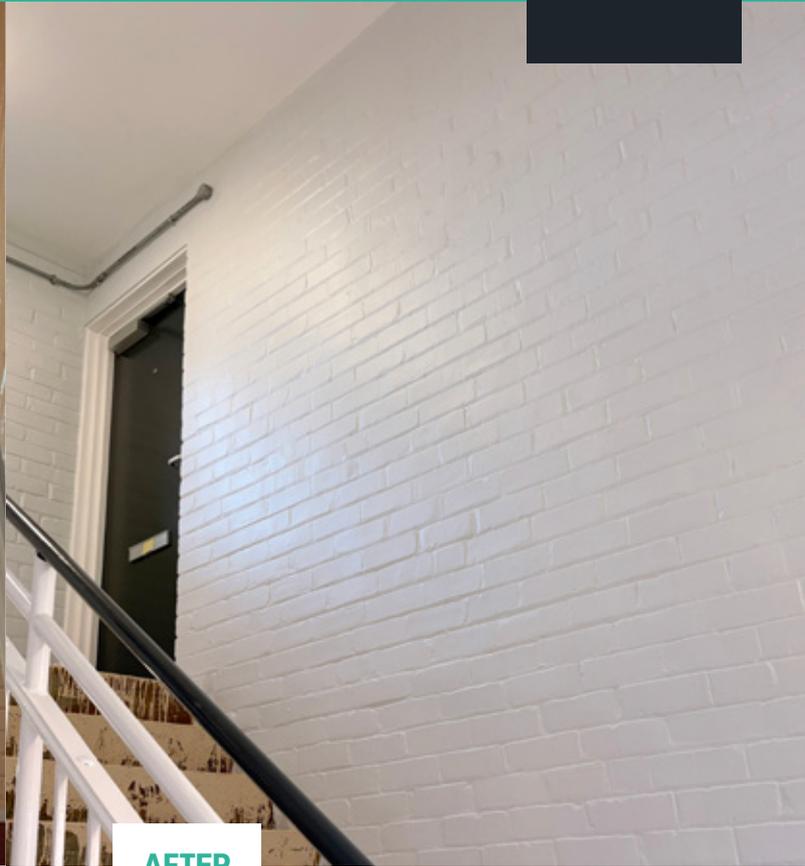
AFTER

To meet Euroclass B fire safety requirements, Torrex 3 was specified. Designed for interior communal spaces, the Torrex 3 fire upgrading coating system is engineered to hold back flames in a fire, giving residents more time to evacuate safely and minimising building damage.
